# Manhole Inspection Summary

Manhole # S71A1\_008MH

Insp Date: **2/12/08 12:28 PM**

**Location** Address: **6607 Pine Ave.**

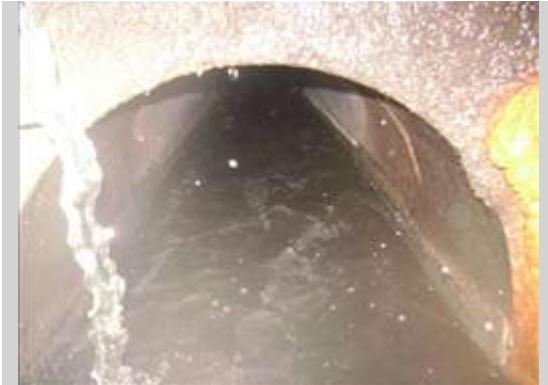
12 O'Clock Outflow

30 in. Circular Gravity Sewer  
Pipe Out @ 12 O'Clock

Pipe Height: **28.8** (in.) Rod Only  
Pipe Material: **Clay** ☐ Pipe Lined  
Invert Depth: **30.17** (ft.) Flow Characteristics: **Fast**  
Deposits: ☒ None ☐ Mud ☐ Sludge ☐ Debris ☐ Grease  
Silt Depth: (in.) Deposits Extent:  
Infiltration: **None** Pipe Seal Cond: **Sound**

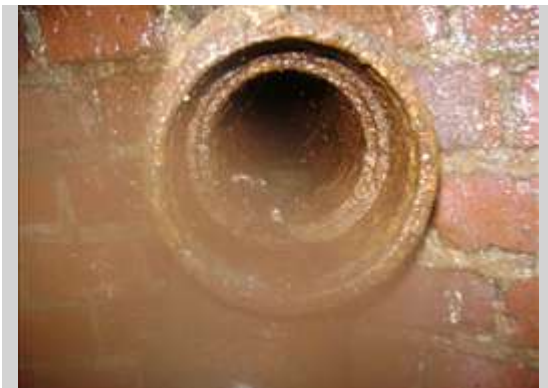
6 O'Clock Inflow

4 in. Circular Gravity Sewer  
Pipe In @ 6 O'Clock

Pipe Height: **3.6** (in.) Rod and Bar (Angled)  
Pipe Material: **DIP/CI** ☐ Pipe Lined  
Invert Depth: **7.25** (ft.) Flow Characteristics: **Fast**  
Deposits: ☒ None ☐ Mud ☐ Sludge ☐ Debris ☐ Grease  
Silt Depth: (in.) Deposits Extent:  
Infiltration: **None** Pipe Seal Cond: **Sound**

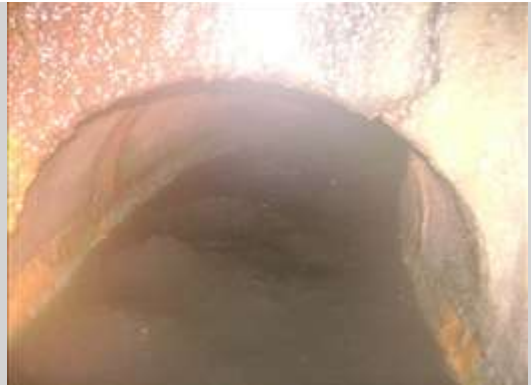
6 O'Clock Inflow

30 in. Circular Gravity Sewer

Pipe Height: **30** (in.) Rod Only

Pipe Material: **Clay** ☐ Pipe Lined
